Manhole Inspection Summary

Manhole # S21E1_003MH

Insp Date: **5/22/08 10:31 AM**

Location Address: **2626A ridgely st**

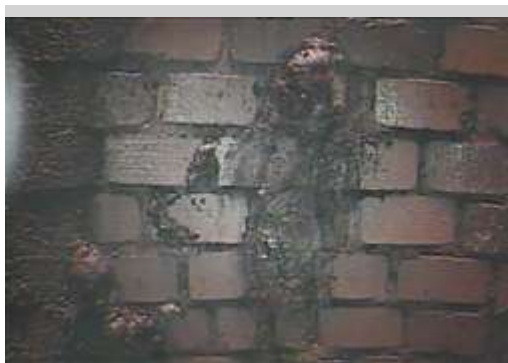
Defect 7

Infiltration: ☐ None ☐ Joint ☐ Cracks ☐ Mortar ☐ Roots ☒ **Wall**

infiltration @ barrel wall

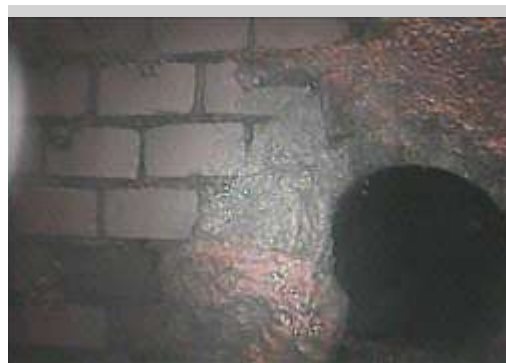
Defect 6

Condition: ☐ Sound ☐ Cracked ☐ Root Intrusion ☐ Loose Brick ☒ **Deteriorated**

encrustation/deterioration @ barrel wall

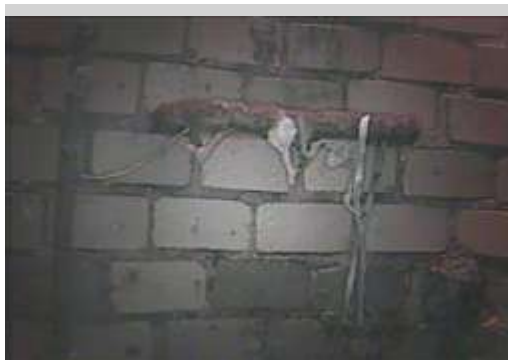
Defect 5

☒ **Evidence Of Surcharge** Depth: **4** (ft.) ☐ Active Surcharge Present

surcharge evidence

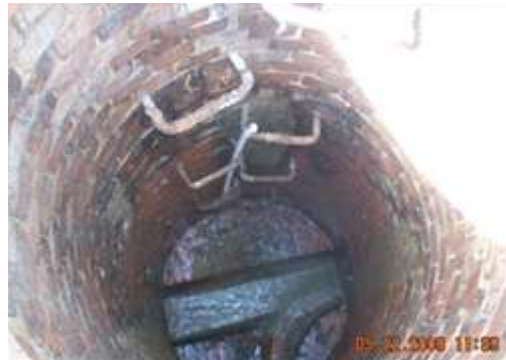
Defect 4

Count: **7** Missing: **0** ☒ **Corroded**

corroded steps

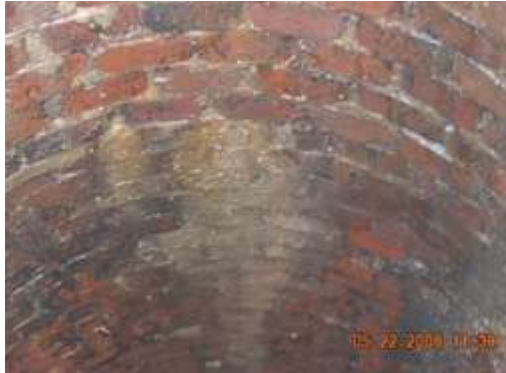
Defect 3

Infiltration: ☐ None ☐ Joint ☐ Cracks ☐ Mortar ☐ Roots ☒ **Wall**

infiltration @ corbel wall

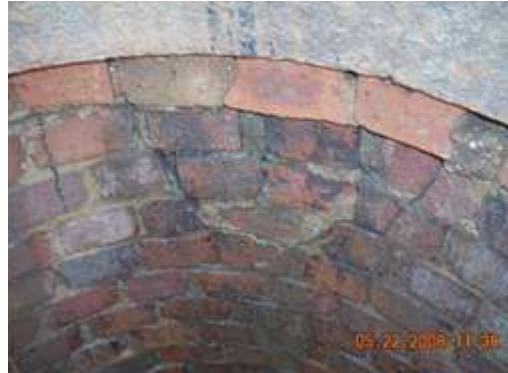
Defect 2

Infiltration: ☐ None ☒ **Joint** ☐ Cracks ☐ Mortar ☐ Roots ☐ Wall

Condition: ☐ Sound ☒ **Cracked** ☐ Root Intrusion ☐ Loose Brick ☐ Deteriorated

cracked corbel bricks, infiltration @ chimney joint

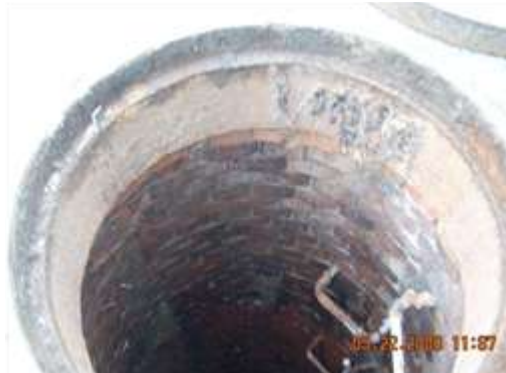
Defect 1

Subject To Ponding: **Sheeting**

inflow evidence from sheeting

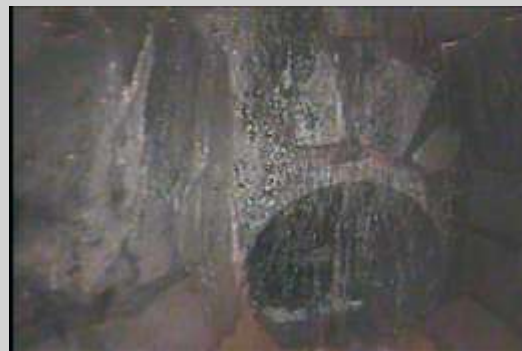
Drop In @ 3 O'Clock

Drop: **Outside** Rod and Bar
Angled: **Yes** Reading: **11.60** (ft.)
Inv Depth: **12.60** (ft.)
Drop Condition: **Partly Clogged**
